FIELD SERVICE BULLETIN

SERVICE DEPARTMENT
CONSOLIDATED VULTEE AIRCRAFT CORPORATION
San Diego, California, U.S.A.

October 15, 1944

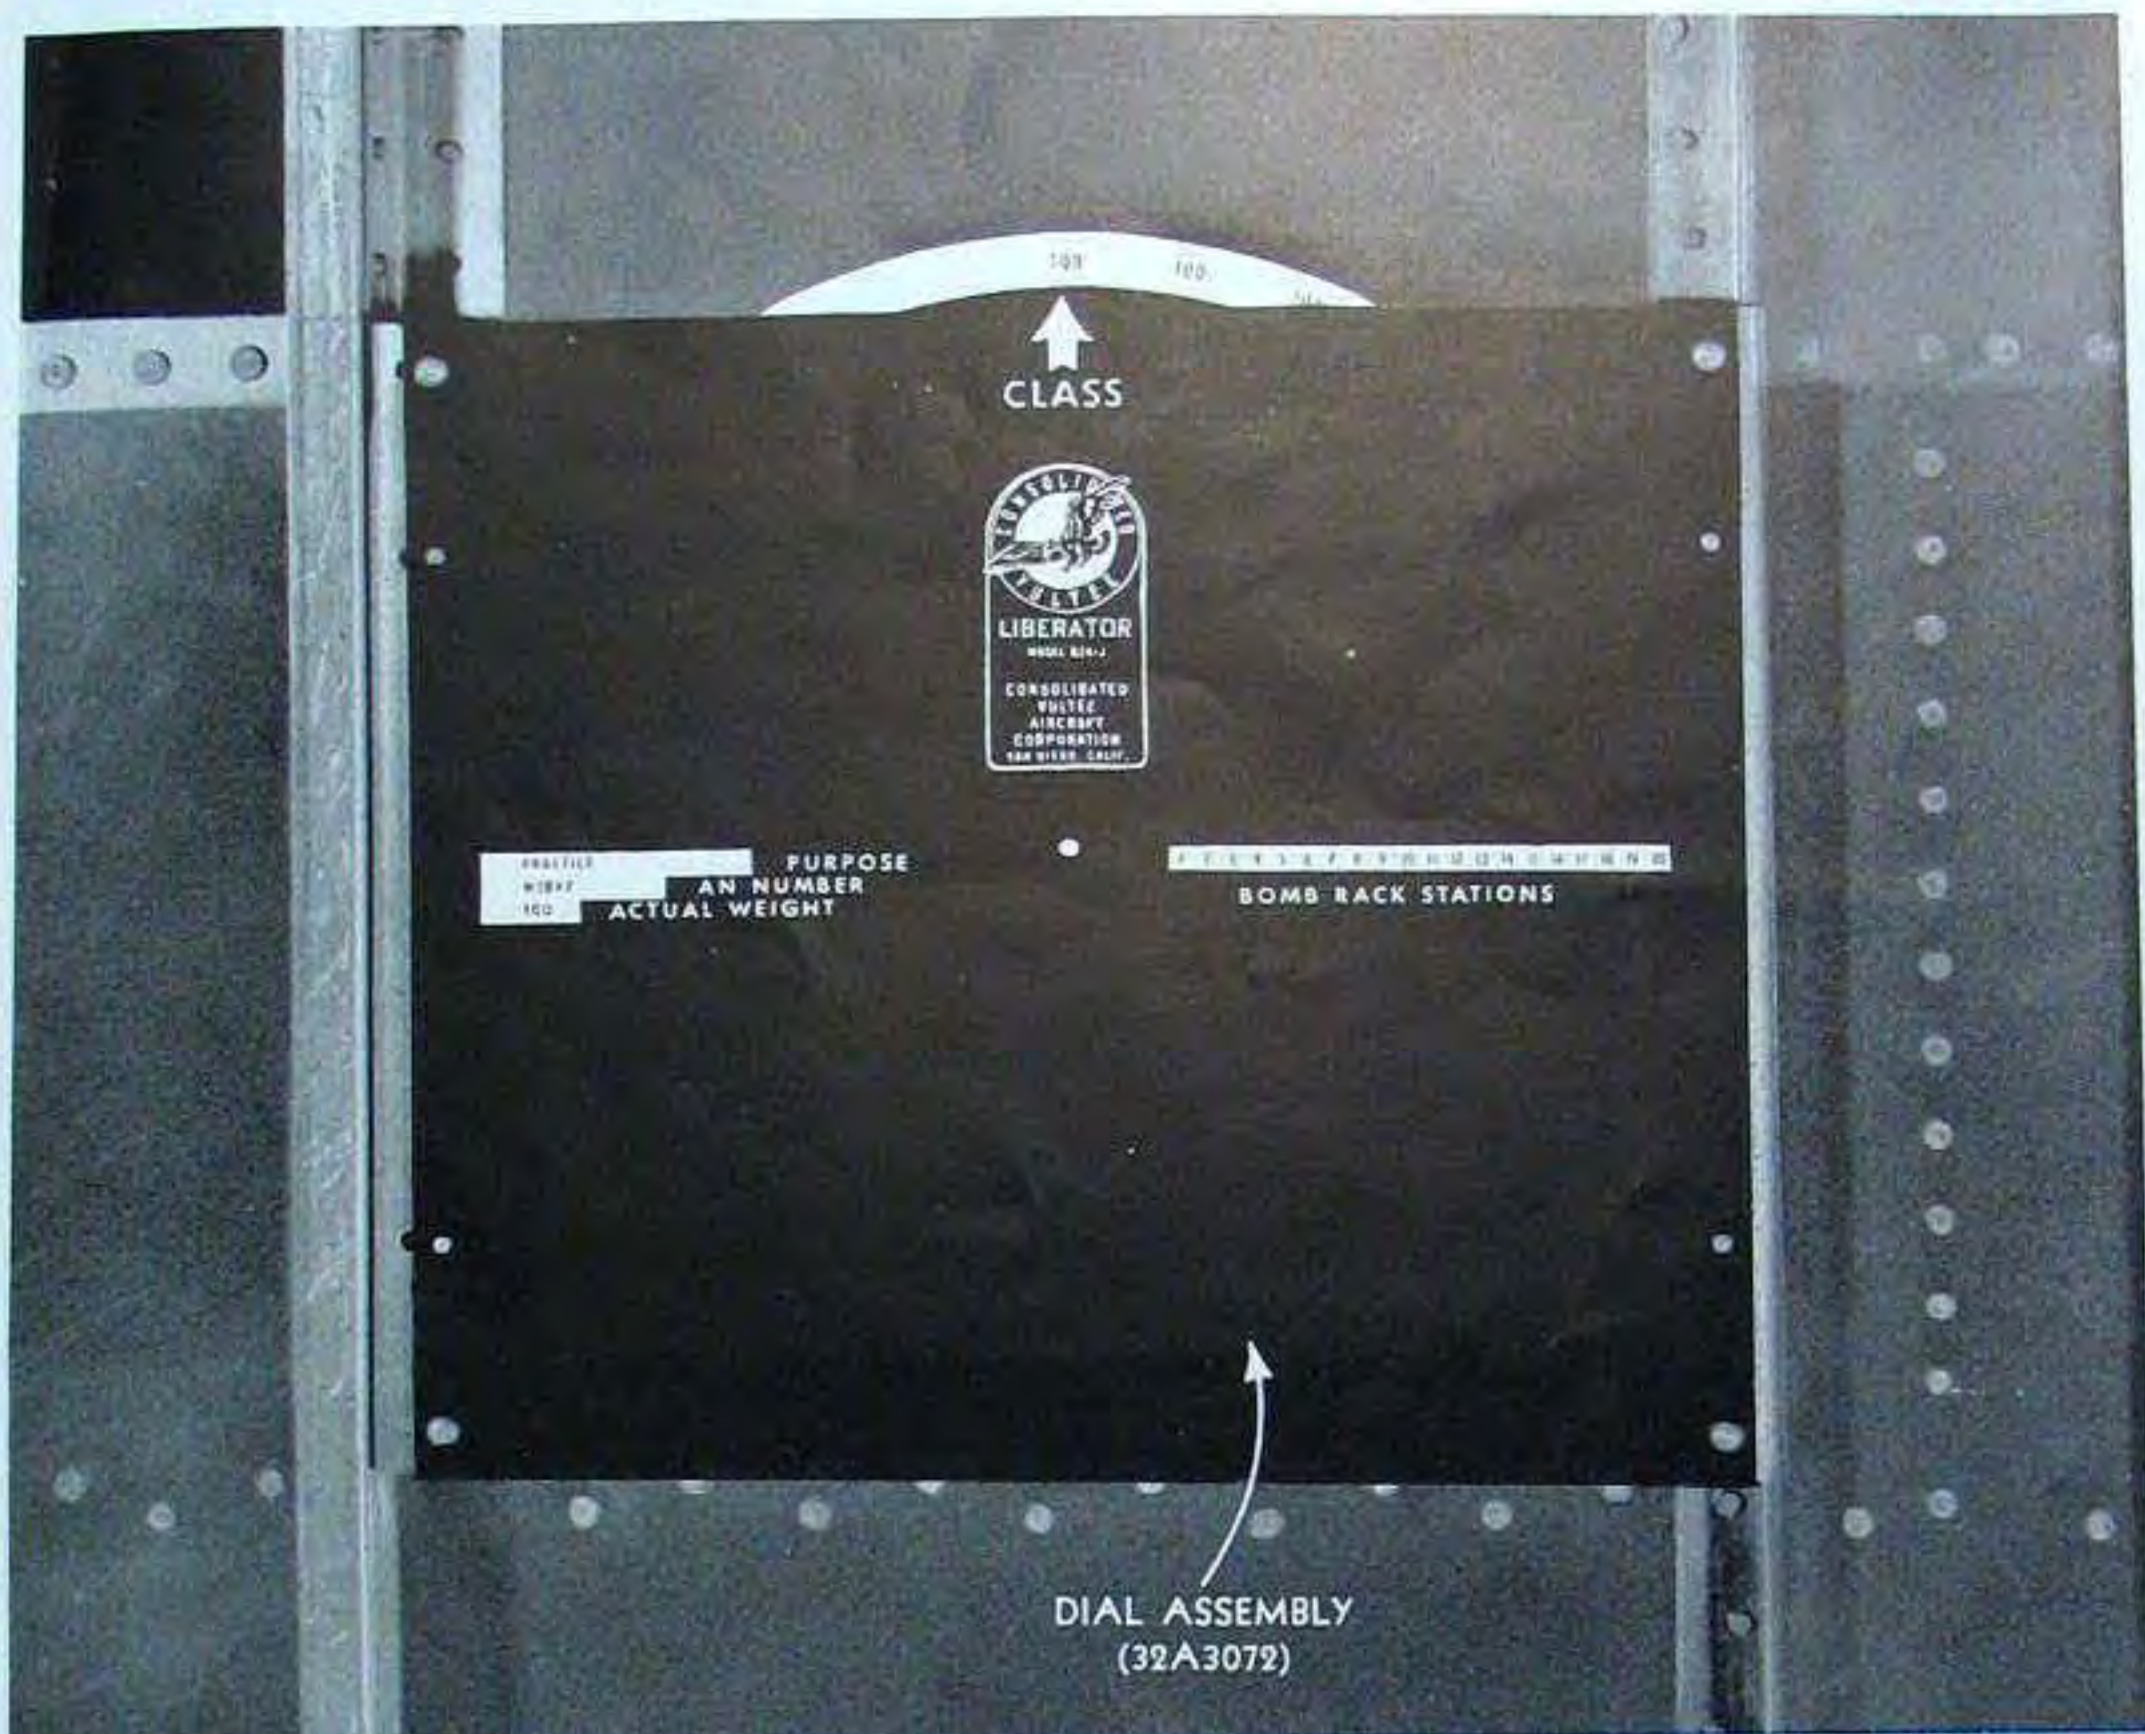
Figure 1. Bomb Loading Identification Placard Installed in Bomb Bay.

A BOMB loading identification placard has been installed on the forward side of the bulkhead at station 6.0, left of the bomb bay catwalk, on B-24 type airplanes.

The bomb identification placard is a dial assembly (32A3072) which consists of a cellulose acetate disc mounted between two stiffening plates (figure 1). The dial was designed to simplify the reading of the bomb

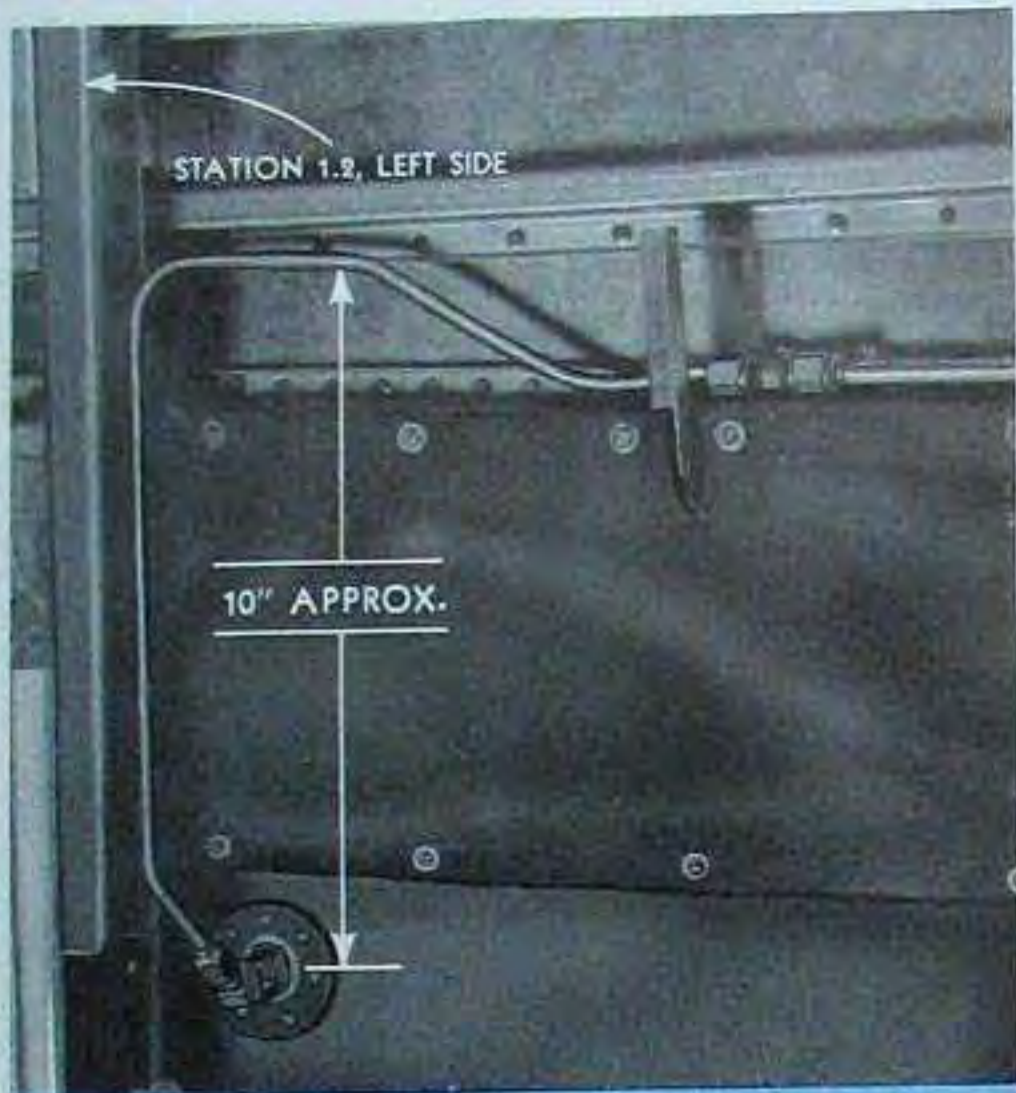
Figure 2. New Routing of Static Air Pressure Tube

THE tubes leading from the static air pressure openings on B-24 type airplanes have been rerouted to prevent moisture from entering the static lines thereby causing erroneous indications of the altimeter, air-speed indicator, and rate-of-climb indicator.

The revised tubes (refer to 32F36100) have been provided with a 10" rise, as illustrated in figure 2. This rise in the tubes is sufficient to keep water out of the static lines; however, the static and pressure lines should be drained periodically to remove any condensed moisture. (Refer to Field Service Bulletin, Volume 2, No. 14, page 200).

Rerouting of the static air pressure tubes is not scheduled for incorporation on aircraft in service.

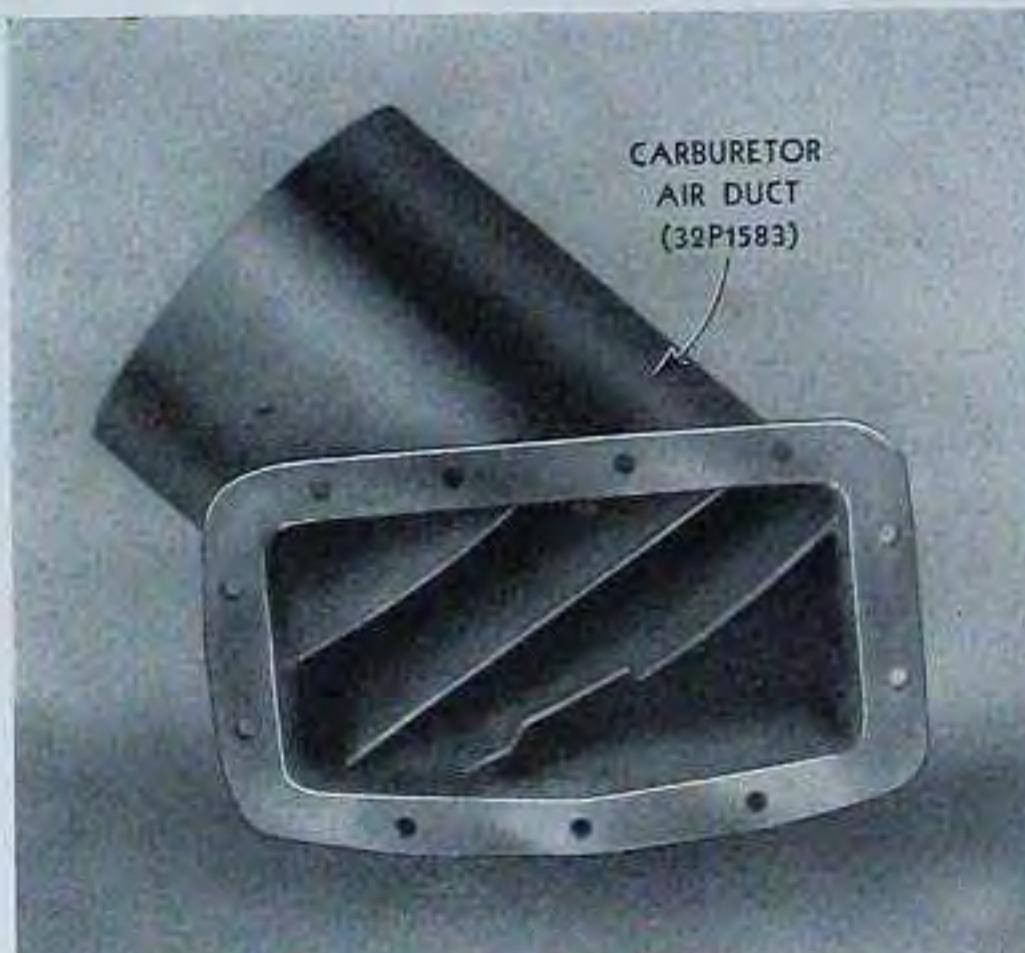
A CAST aluminum carburetor air duct (32P1583), incorporating cast-in vanes, has replaced the former riveted vane ducts installed on B-24 type airplanes (figure 3). Cast aluminum construction eliminates the use of rivets and is superior in strength to the riveted vanes.

The cast-in vanes are capable of withstanding higher vibrational loads and will eliminate the possibility of broken parts and rivets dropping into the blower section of the engine with consequent damage to aircraft and equipment.

Figure 3. Cast-In Vane Carburetor Air Duct, Rear View

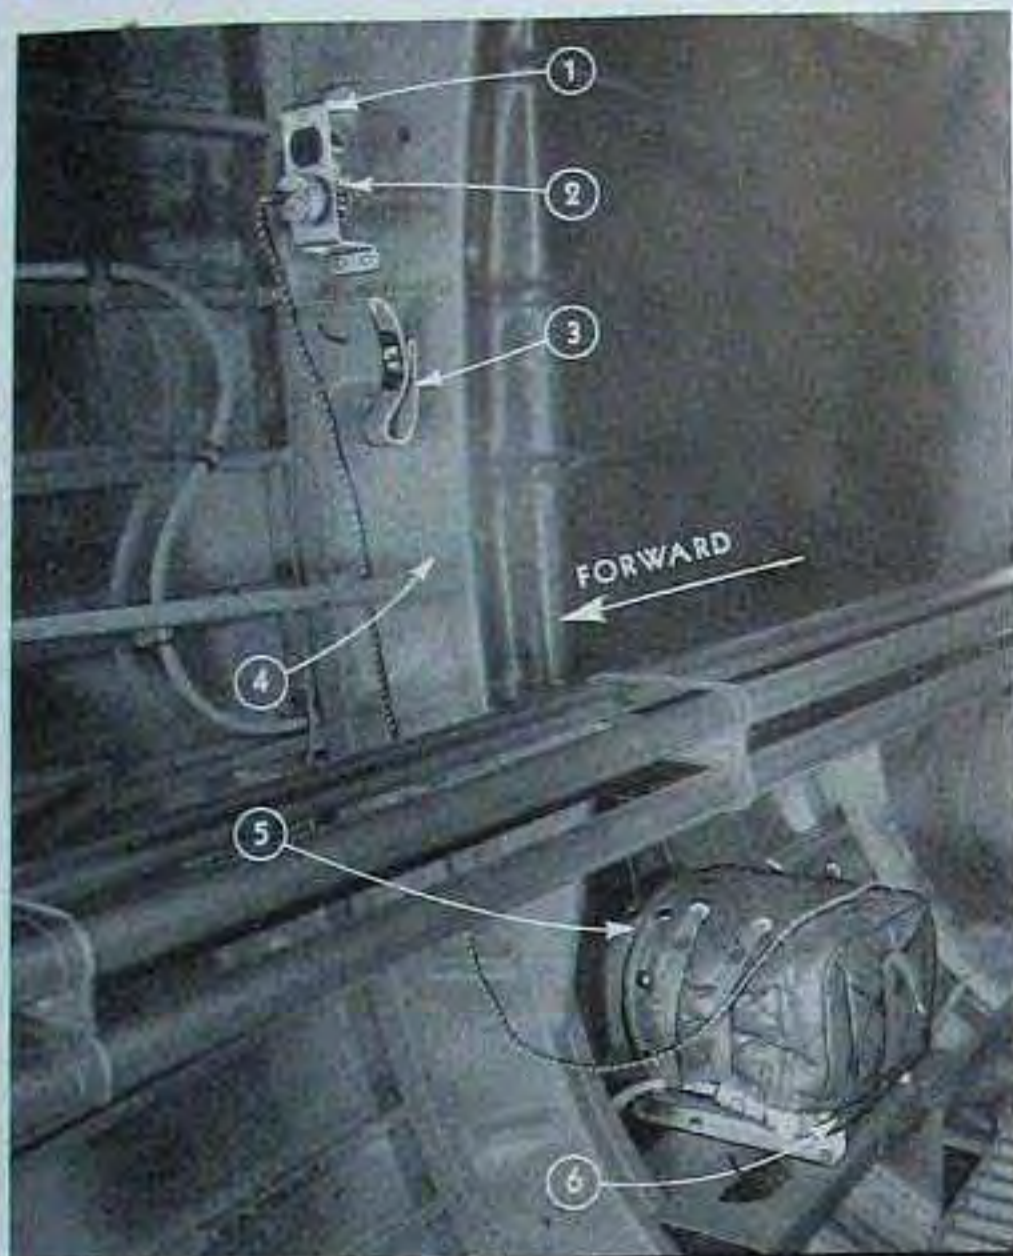
Figure 4. Servo Motor Heating Pad Installed

A HEATING pad unit has been installed on the elevator servo motor of B-24 type airplanes to prevent malfunctioning of the unit during operation in freezing temperatures. An electric receptacle has been

The heating pad installation (figure 4) consists of a cover (5), base pad (6), and six mounting spacers. An electric cord is supplied with the heating pad. An electric receptacle (2) has been installed on the right forward face of the bulkhead at station 8.0. An electric harness has been installed to connect the receptacle with the tail turret power switch box where a 2 ampere fuse is installed for the heating circuit. A strap (3), installed below the electric receptacle, provides safe and convenient stowage for the electric cord.

Installation and operation of the heating pad are described in Technical Order No. AN-1160AA-1, page 98.

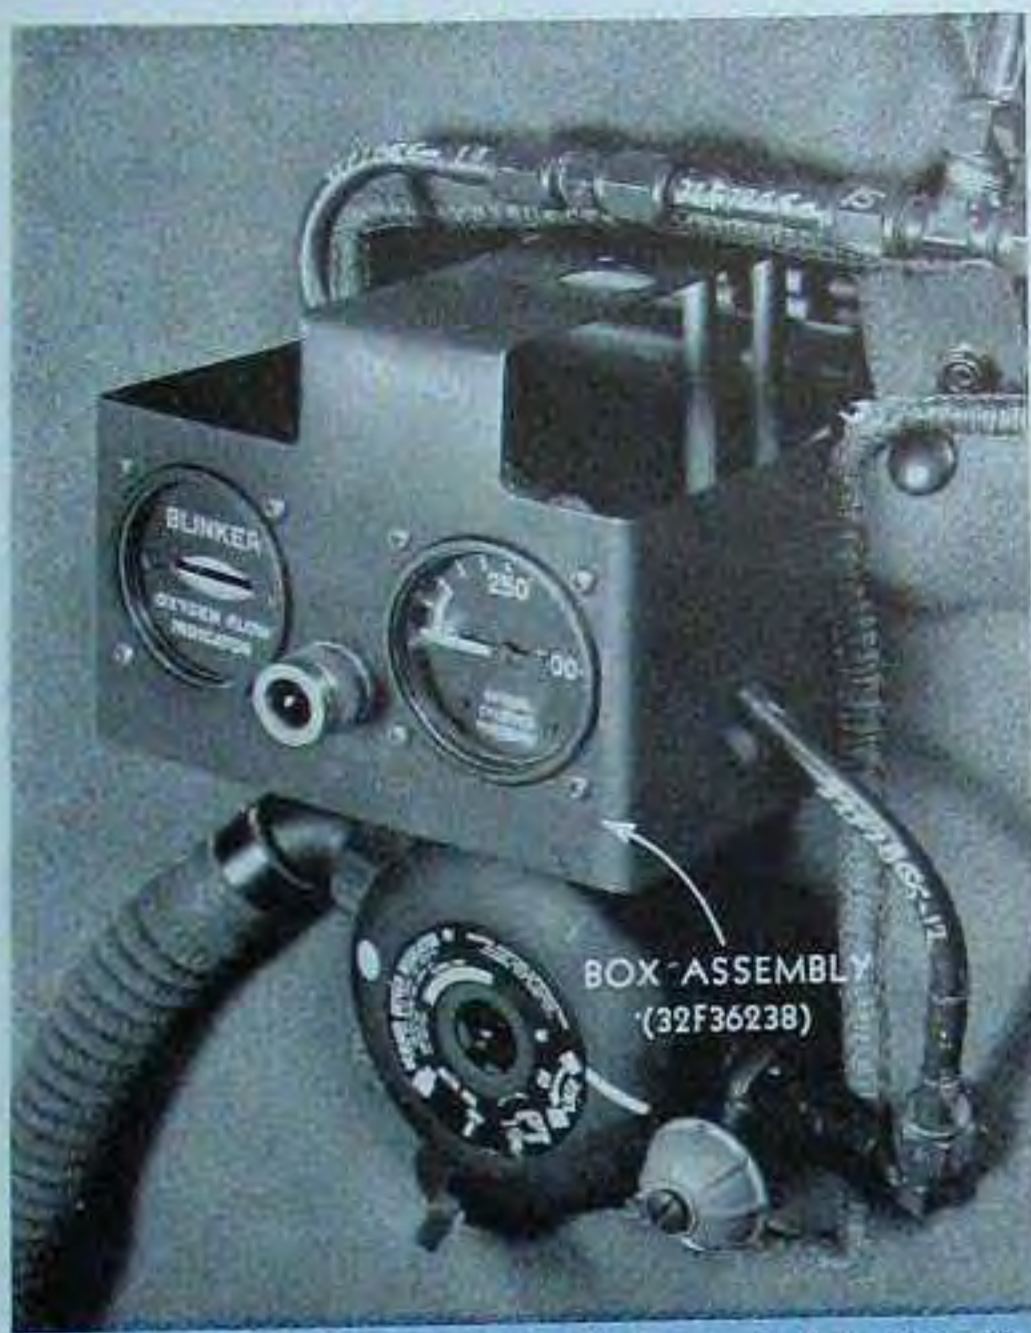
Figure 5. Typical Installation of Improved Box Assembly

AN IMPROVED box assembly for the demand oxygen system panels has been installed on B-24 type airplanes.

The new box assembly (32F36238), installed under 32F36239, is made of alclad sheet and has been designed with maximum allowable cutouts (figure 5). These cutouts provide greater accessibility for the removal and inspection of instruments and fittings without the necessity of dismantling the panels.

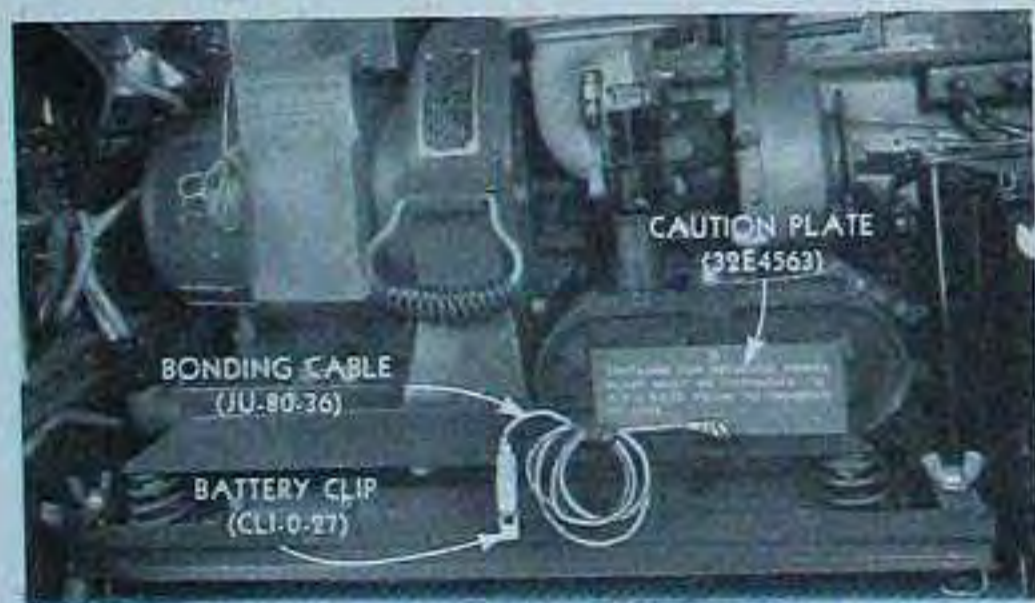
Figure 6. Auxiliary Power Unit Grounded to Base

A BONDING CABLE (CVAC Part No. JU-80-36) and a battery clip (CVAC Part No. CLI-0-27) have been installed on the auxiliary power unit of B-24 type airplanes as a precautionary measure to prevent possible fire which could be caused by an accumulation of static electricity in the power unit.

The unit, located on the left side of the fuselage forward of the bulkhead at station 4.0, is grounded by attaching the battery clip to the base of the unit prior to refilling the fuel tank (figure 6).

A new cautionary plate (32E4563) has been installed on the unit to inform personnel of the grounding procedure before refilling the fuel tank of the auxiliary power unit.

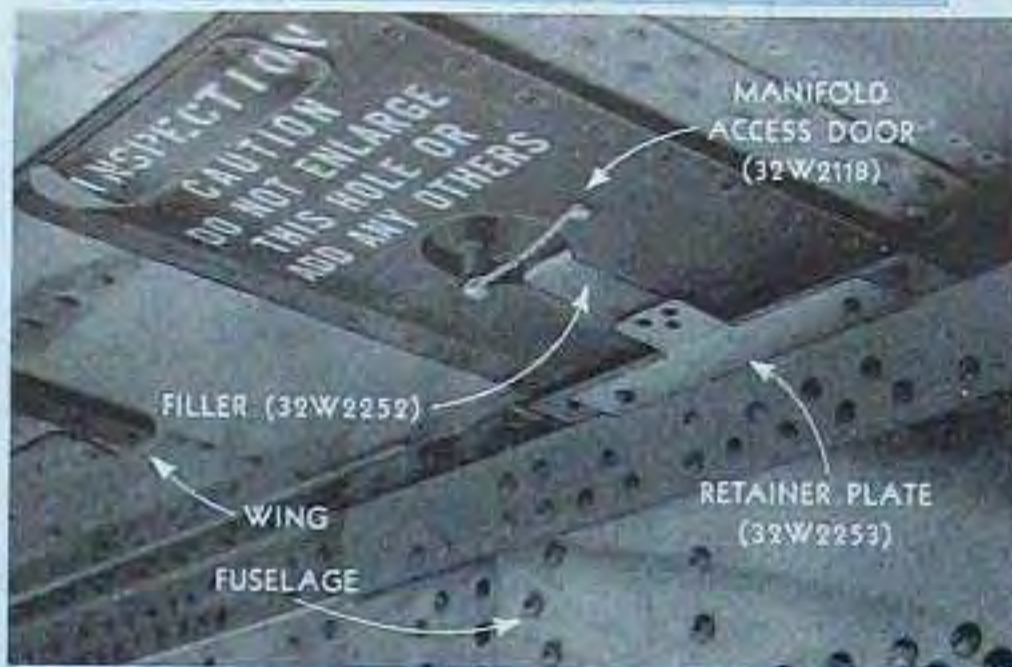
Figure 7.

PREMATURE deterioration of the No. 2 main fuel cell manifolds in the wing has necessitated covering the No. 2 cell manifold drain openings in the manifold access doors at wing station 2, left and right.

Installation of a filler block (32W2252) in the opening (figure 7), prevents air from circulating around the fuel cell manifold, thus retarding deterioration of the synthetic rubber manifold. A retainer plate (32W2253) has been installed on the outside of the access door to hold the filler block in position.

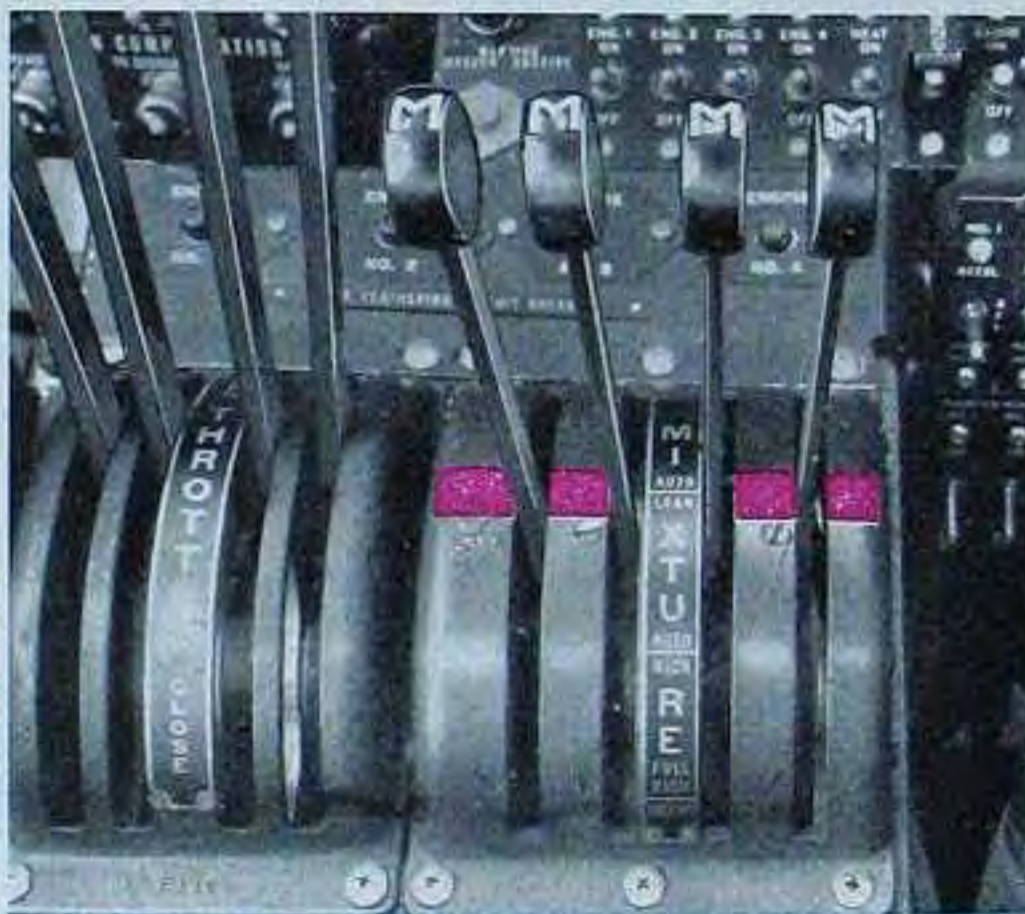
The Technical Order further directs the painting of a red band across the carburetor mixture control quadrant, centered at the auto lean position, after the controls have been re-rigged. This band, the exact width of the control levers (figure 8), serves to notify the pilot of properly rigged carburetor mixture controls.

Improper rigging of the carburetor mixture controls can cause malfunction of the engine due to the lean metering of fuel. The mixture control selectors on the carburetors, when in the auto lean position on all four engines, must coincide with the auto lean position of the mixture control levers on the pilot's pedestal.

Figure 8. Mixture Control Quadrant Mark at Auto Lean Position

THE mixture control linkage of B-24 type airplanes will be inspected to comply with Technical Order No. 01-5E-48. In the event the mixture control selectors on the carburetors do not coincide with the mixture control levers on the pilot's pedestal, the linkage should be disassembled and re-rigged.

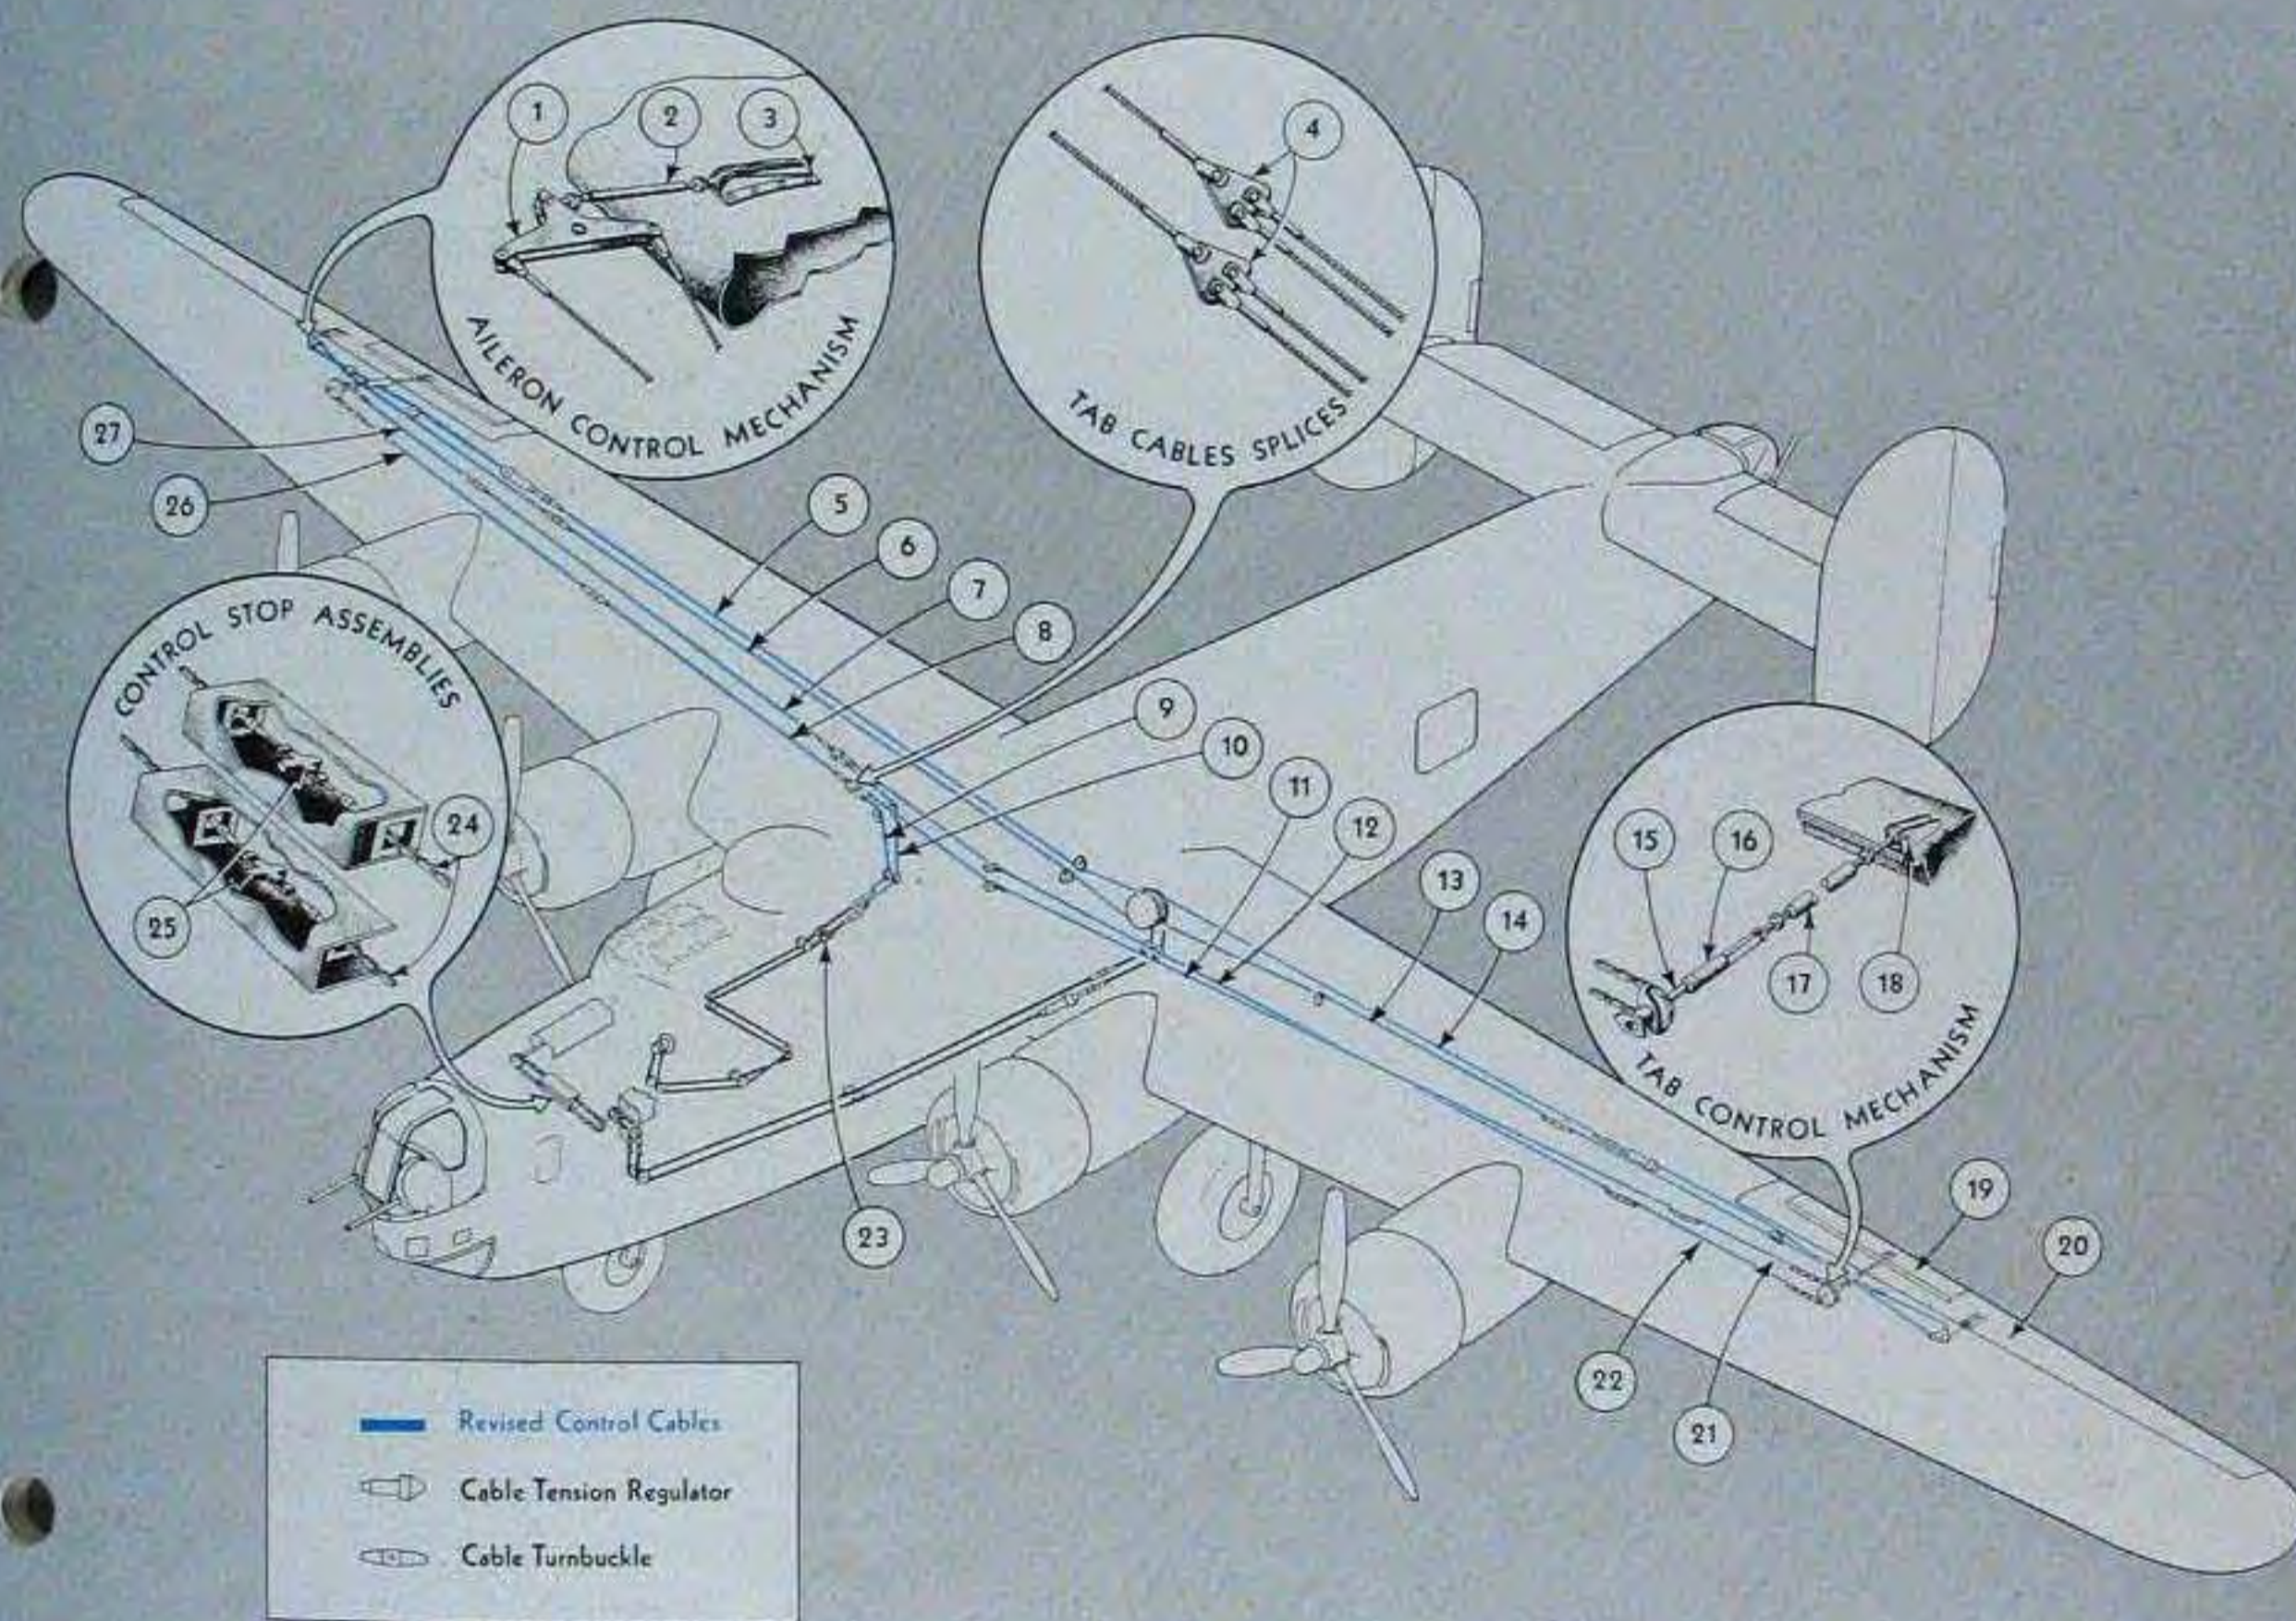
THE aileron and aileron tab control systems have been modified so as to incorporate a tab in the left aileron and to provide for the installation of bell cranks in place of aileron gear boxes. (Refer to figure 9.)

A TAB (19) (32W1315L) has been added to the left aileron (20) (32W573-4L) to improve the effectiveness of the aileron tab system. The need for more tab surface has developed as a result of the increase in gross weight and engine power, and the addition of auxiliary wing fuel cells. The single aileron tab installation was suitable for the B-24 airplane of 41,000 lbs. gross weight (original B-24 specification).

servo action of the tabs when the ailerons are deflected 20° (aileron deflection limit 20° up, 20° down). The former tab control mechanism (32W586) did not provide servo action. The universal joint has been removed from the revised tab control mechanisms.

INCORPORATION of the single horn installation on the ailerons has necessitated a change of the aileron structure to distribute the concentrated load of the single control horn.

The outer wing panel rear spar has been changed to accommodate the bell crank installation. Slots cut in the rear spar allow passage of the bell crank and cables. Reinforcing angles have been added adjacent to the slots to maintain the required strength of the spar.

Figure 9. Revised Aileron and Aileron Tab Control Systems

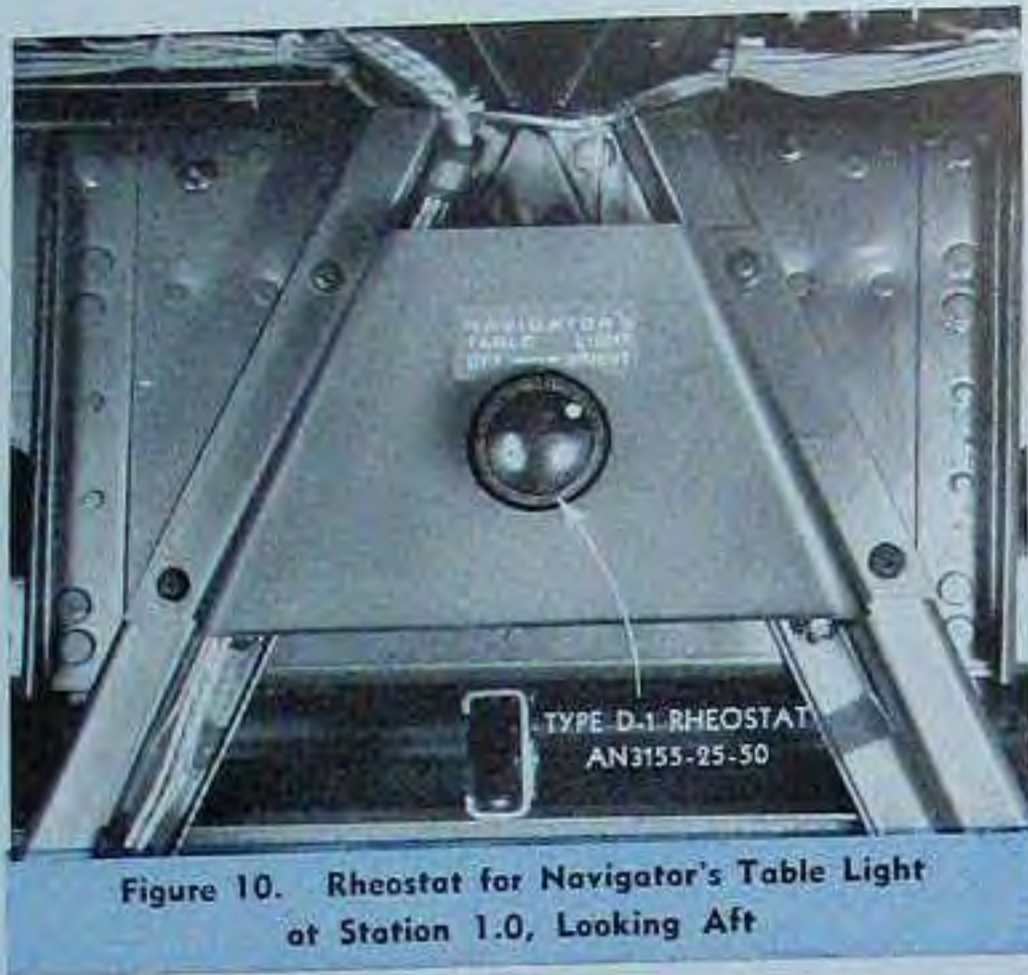
Figure 10. Rheostat for Navigator's Table Light at Station 1.0, Looking Aft

A TYPE D-1 rheostat (AN3155-25-50) has been installed in the A-11 lamp assembly on the navigator's chart table in order to provide a means for dimming the navigator's light. Instructions, painted with a fluorescent material on the light rheostat panel (figure 10), indicate to the navigator the proper direction for dimming the light.

The former A-11 lamp assembly, controlled by a toggle switch (AN3015), lighted the entire nose of the airplane causing danger of detection by enemy aircraft at night. The reflection from the navigator's table to the celestial dome caused a glare which had a tendency to impair the vision of the pilot and the copilot during night flying.

Service Bulletin No. 32-3A-423 has been issued to replace the toggle switch with a type D-1 rheostat on delivered airplanes.

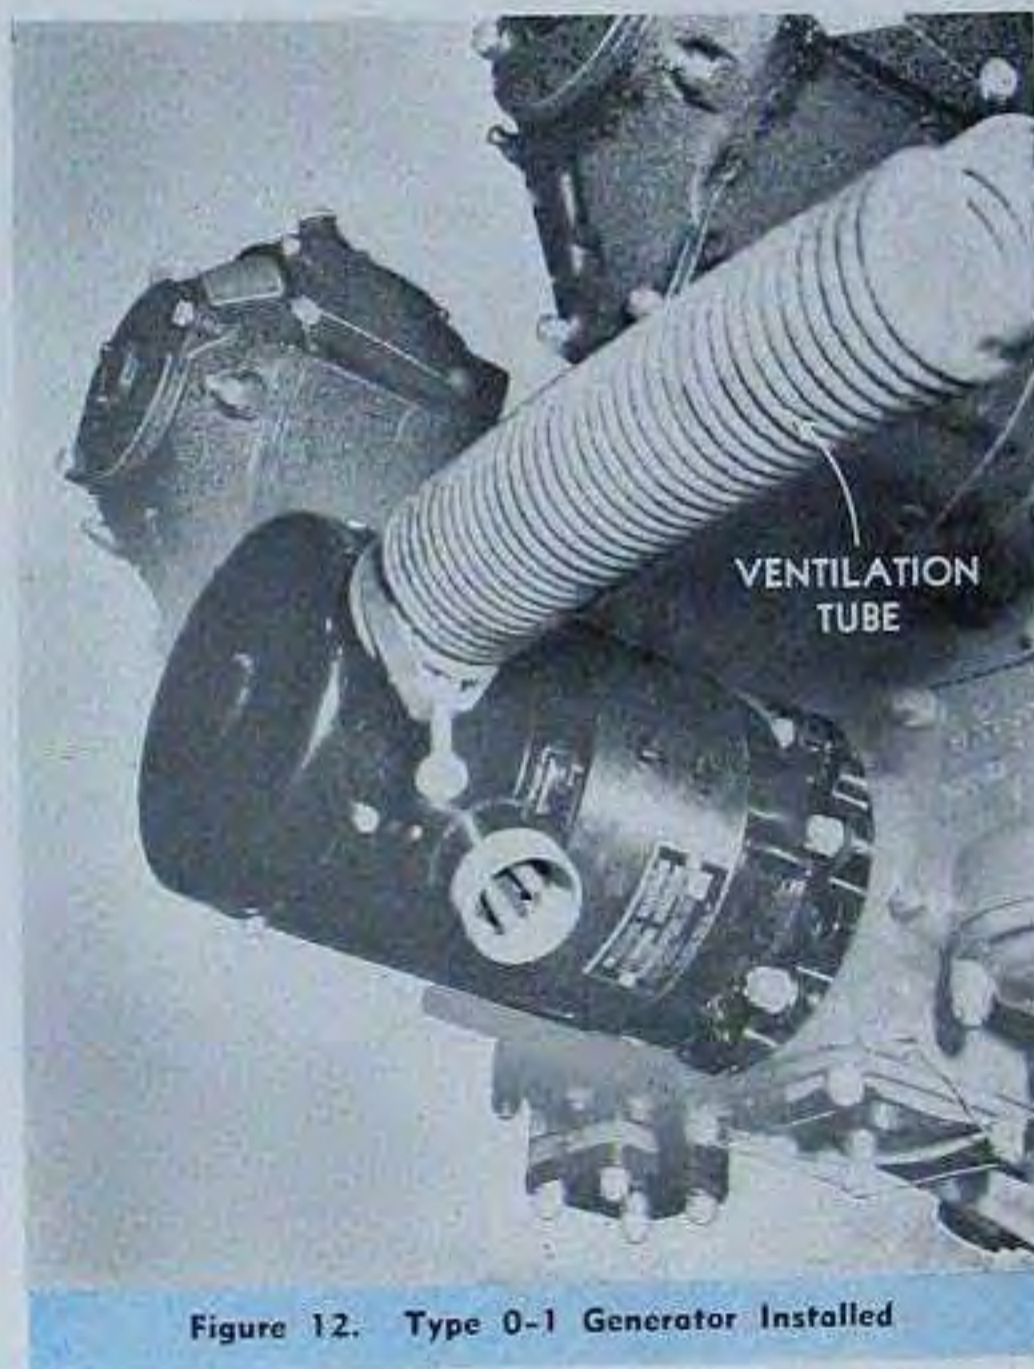
THE type P-1 (200 ampere) generator has been replaced with type O-1 (100 ampere) generator on C-87 airplanes beginning with A.A.F. Serial No. 44-39265.

A few periodic checks will insure continued normal operation of the O-1 generator and will prevent failures which could possibly be caused by neglect. Lubrication of the new type generator is not required since the ball bearings are lubricated and sealed at the factory. Replacement of these bearings is recommended only at the regular overhaul period.

Figure 12. Type O-1 Generator Installed

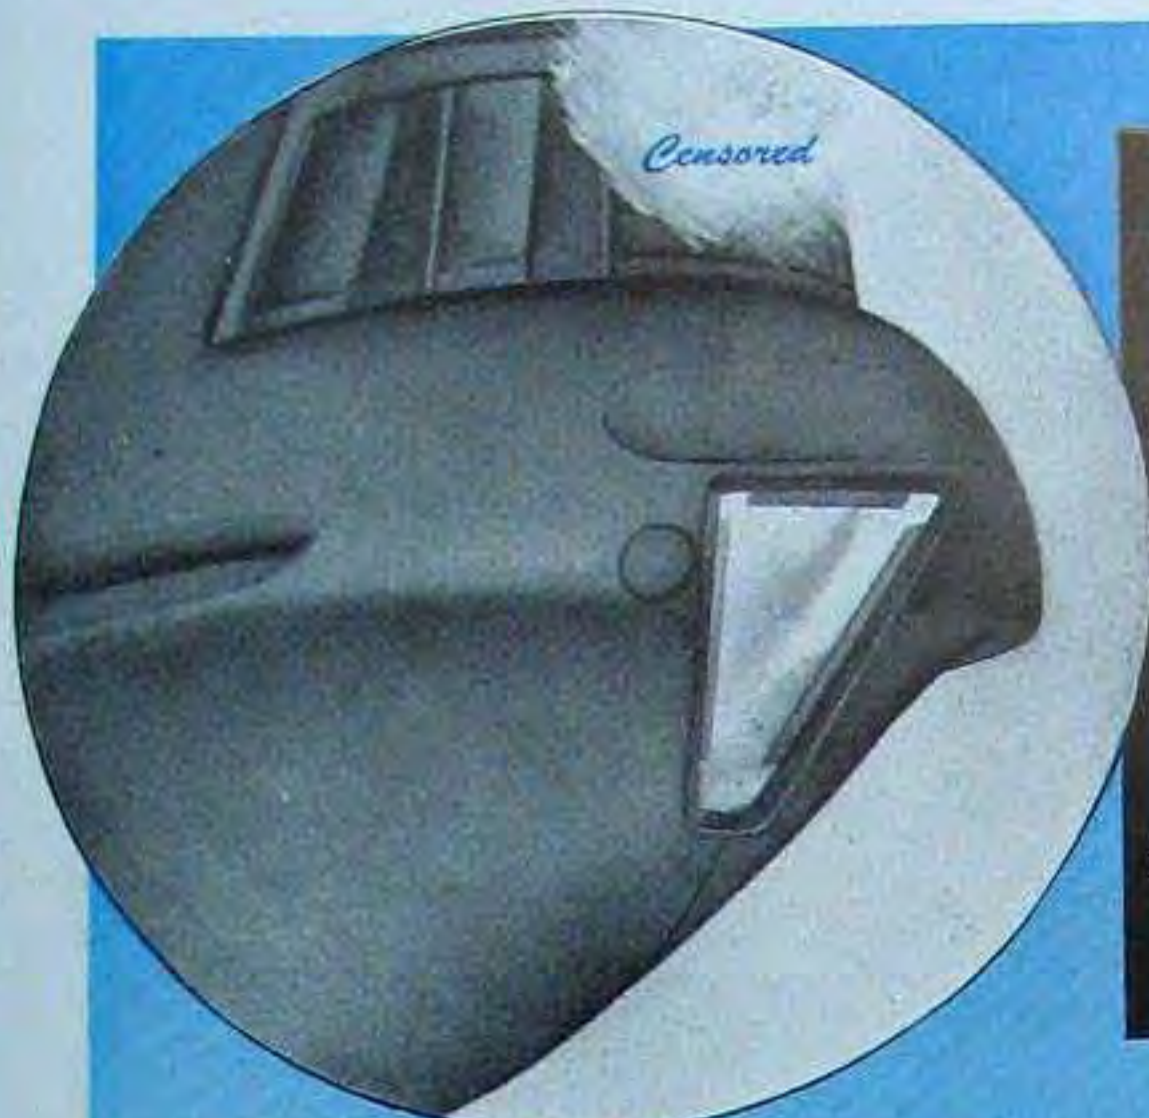
Figure 13. Redesigned Bombardier's Window Installed.

A plane, four-sided window with two parallel sides (figure 13) replaces the former rectangular window. Installation of this trapezoidal-type window and backing door necessitated removal of the sliding shutter and accompanying mechanism, and the rectangular window and backing door.

1. Elimination of many parts, thereby releasing critical materials and reducing the man-hours necessary for fabrication.
2. Prevention of water leaks by utilizing the extended Vinyl as a seal. This also eliminates the possibility of leaks in the shutter retracting well.
3. The smaller frontal area results in cleaner bow lines.
