FIELD SERVICE BULLETIN

SERVICE DEPARTMENT
CONSOLIDATED VULTEE AIRCRAFT CORPORATION
San Diego, California, U.S.A.

October 15, 1944

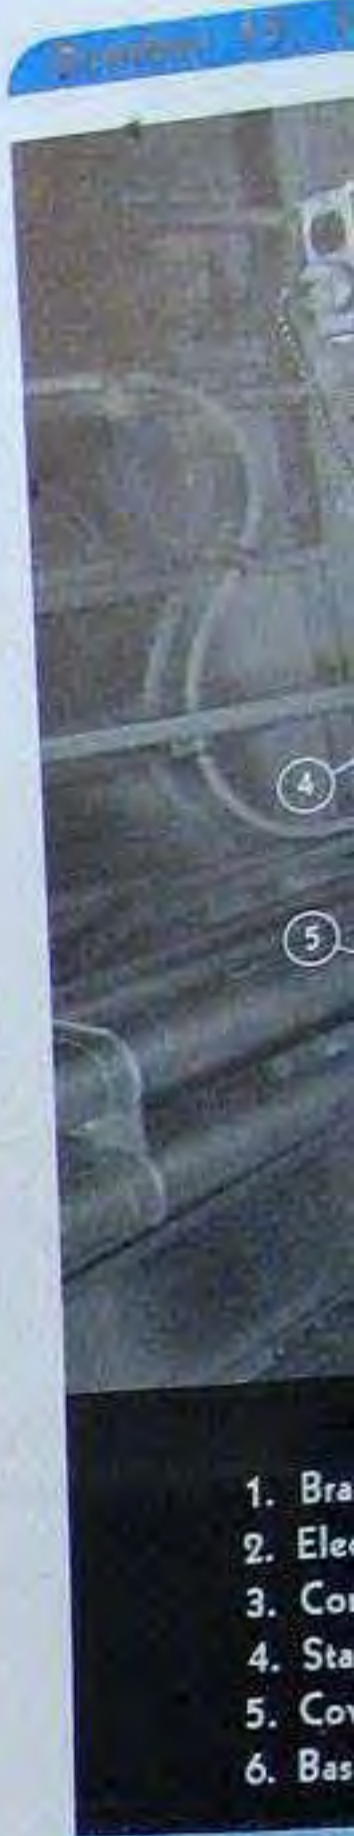
Figure 4.

The heating pad installation (figure 4) consists of a cover (5), base pad (6), and six mounting spacers. An electric cord is supplied with the heating pad. An electric receptacle (2) has been installed on the right forward face of the bulkhead at station 8.0. An electric harness has been installed to connect the receptacle with the tail turret power switch box where a 2 ampere fuse is installed for the heating circuit. A strap (3), installed below the electric receptacle, provides safe and convenient stowage for the electric cord.

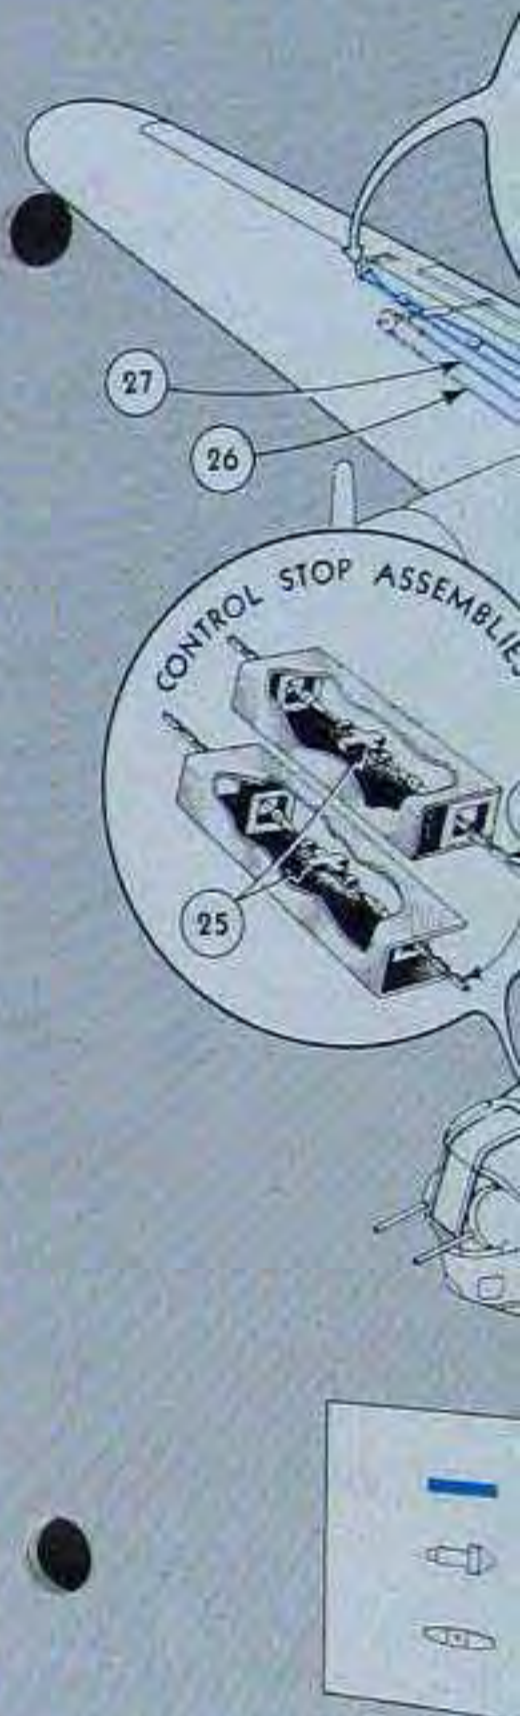
B-24 TYPE AIRPLANES

The revised installation provides a single bell crank (1) and aileron horn (3) for each aileron. The single point control installation reduces operating friction and simplifies installation of the aileron control system. The bell crank installation requires less movement of control cables to obtain a full deflection of the ailerons. Consequently, the maximum turning limit of the pilot's aileron control wheel has been reduced. A revised aileron control stop assembly (refer to inset) has been installed in the aileron control chain assembly (24) which connects the pilot's and copilot's control columns.

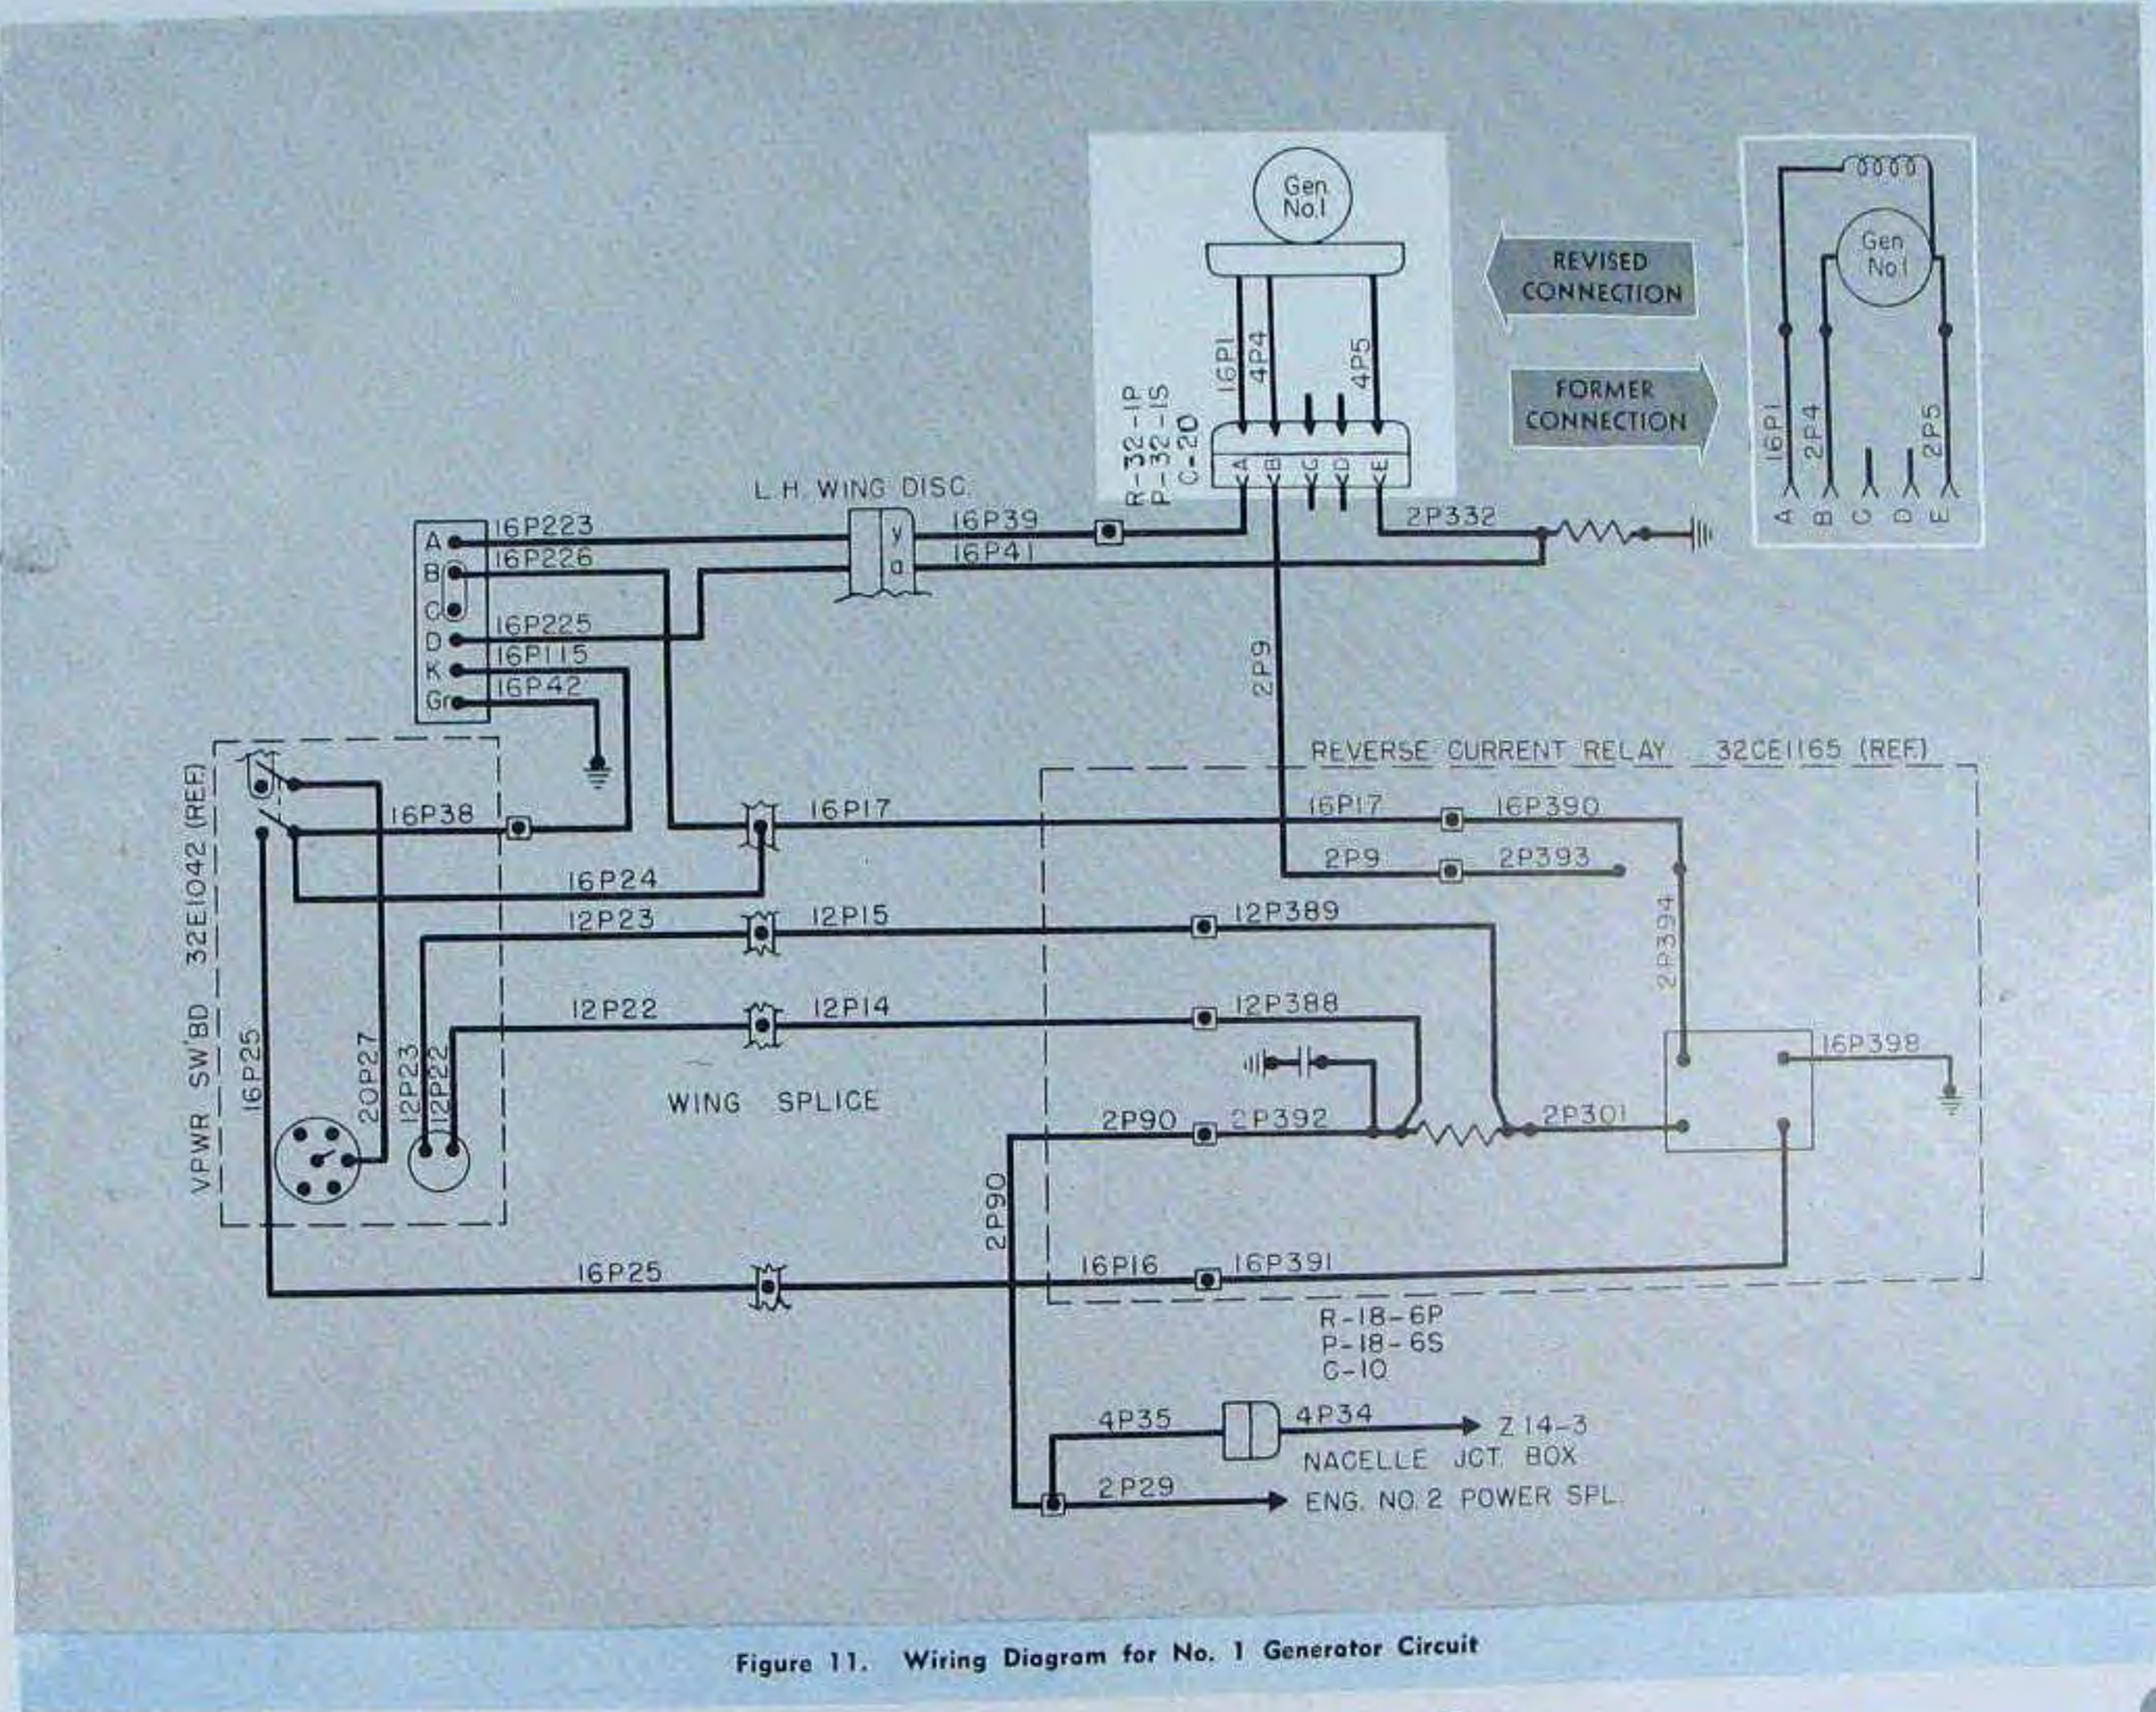
Figure 11. Wiring Diagram for No. 1 Generator Circuit

The type O-1 generator, manufactured by the Leece-Neville Co. of Cleveland, Ohio, (figure 12) is interchangeable with the P-1 generator except that they require different type resistors. Resistor (RES-8-60-FW) is used with the 100 ampere generator, and resistor (RES-8-50-FW) is used with the 200 ampere generator. Necessary changes were made in wiring sizes to accommodate the smaller generator (figure 11).

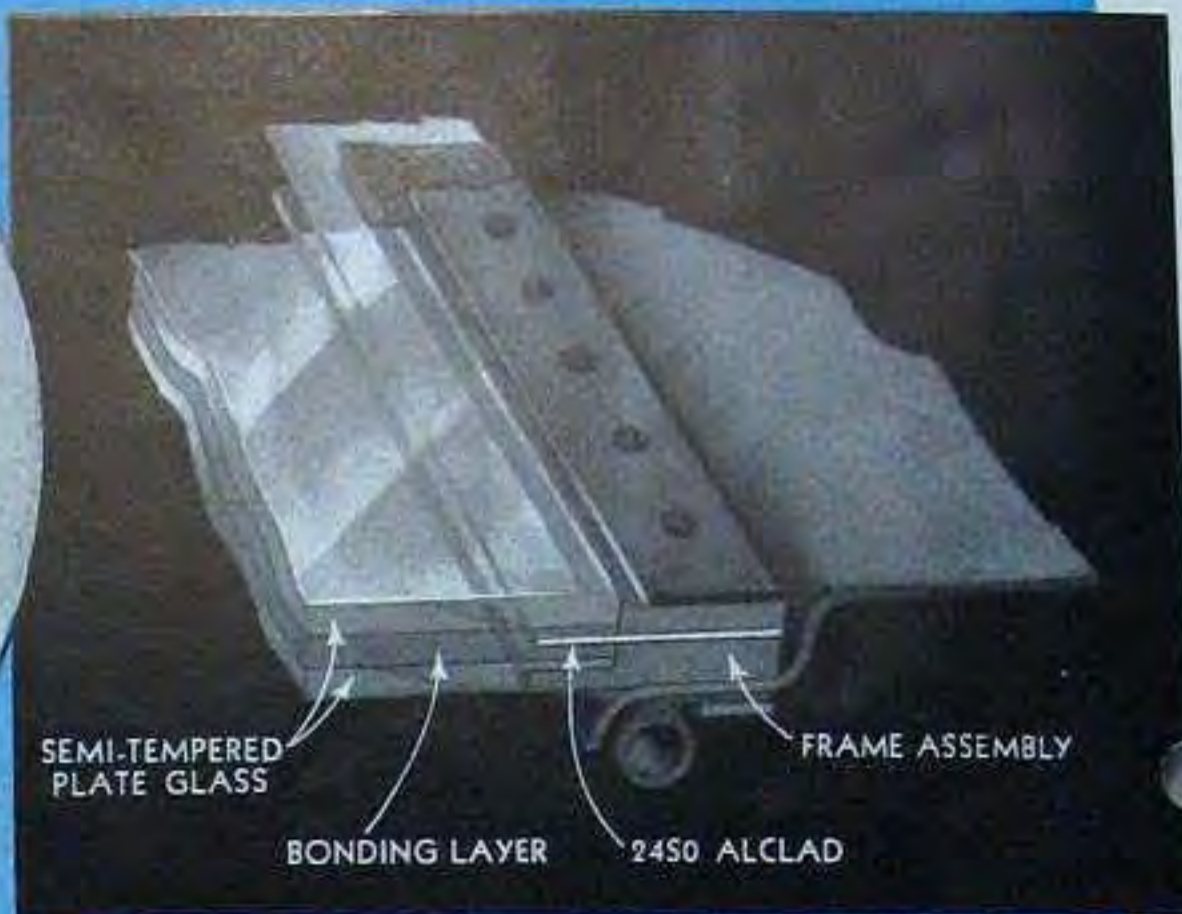
Figure 14. Cutaway View of Bombardier's Window.

The new glass (figure 14) is of three-ply laminated construction; the two outer plies are semi-tempered plate glass, 3/16" thick; the inner ply, or bonding layer, is Vinyl plastic, 3/16" thick. The frame construction of the glass is of Vinyl plastic, reinforced with a strip of 2450 alclad which extends back into the
